# Tube Bundle Warranty Guide

# Water Chemistry

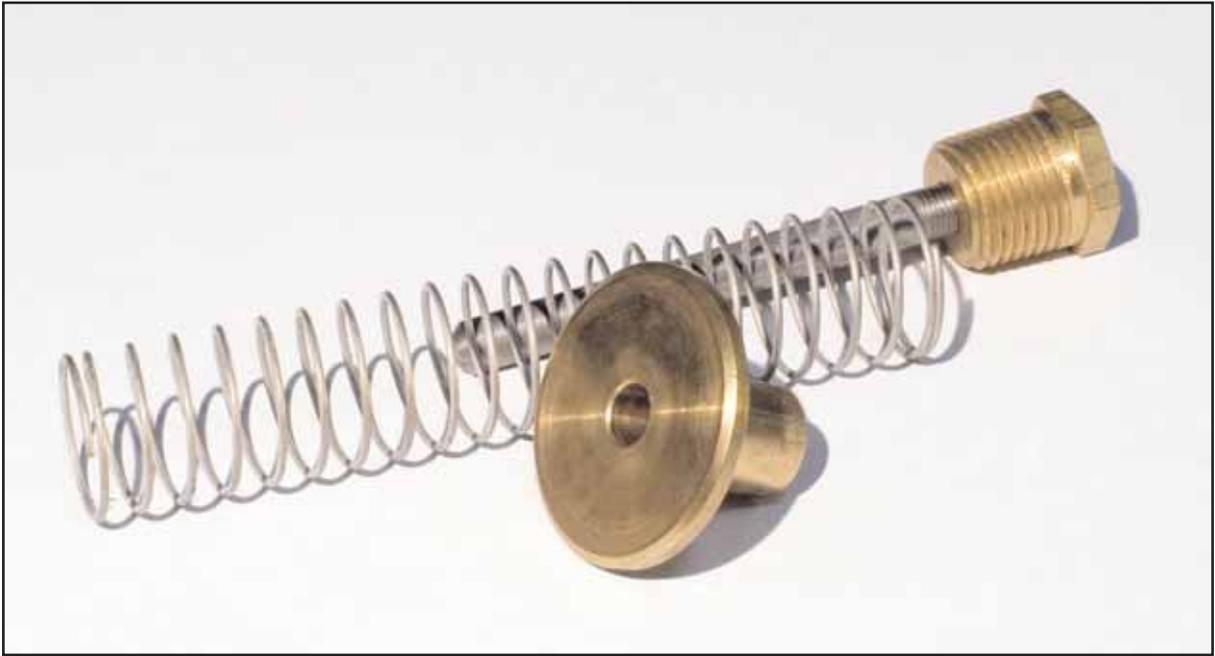
# Good Internal Parts

Manual Bypass Assembly-ASME heaters

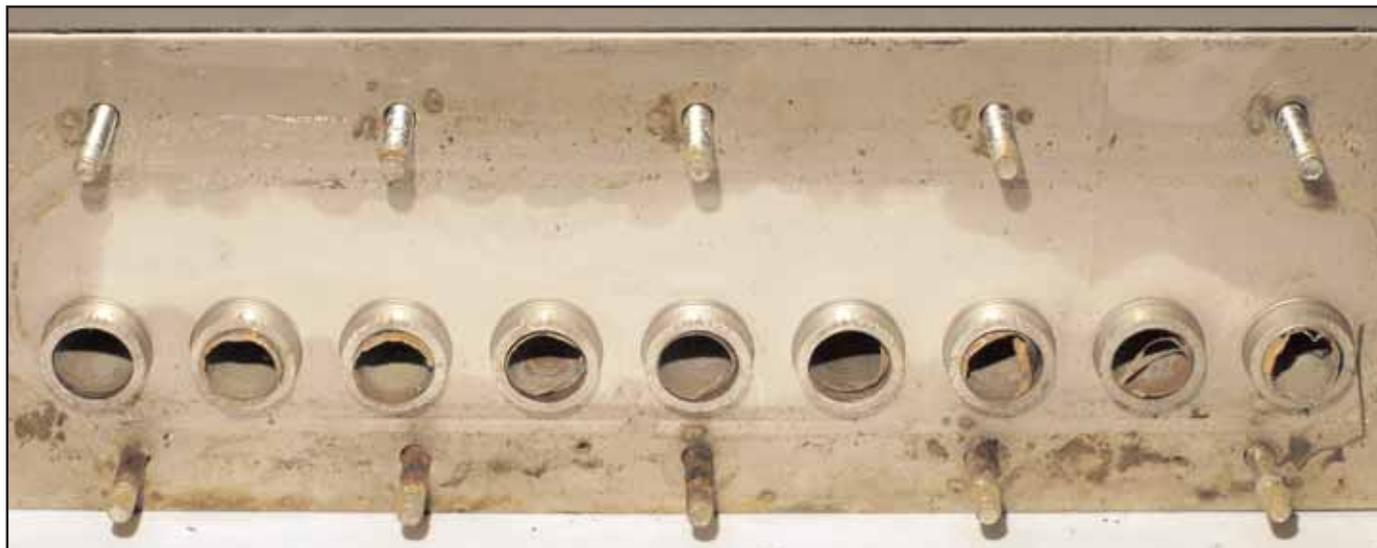
pH < 6.0 Alkalinity = 0

Ends of the tubes are worn thin.

When chlorinating the water with chlorine tablets that have a pH of approximately 3.0 and the pH and alkalinity of the water are not properly maintained, the pH level of the water will drop below 6.0. The water may look crystal clear, but the pH of the water will be so low that it will dissolve the copper tubing in the heat exchanger and cause failure.

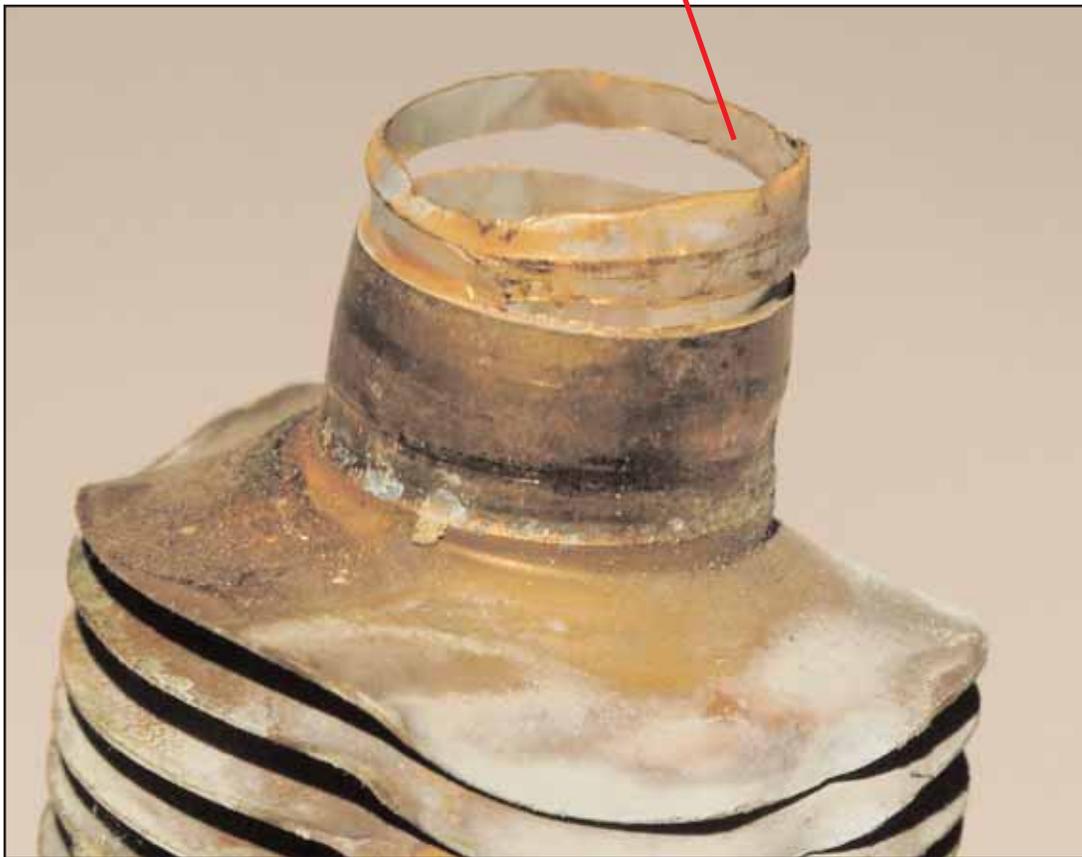
Rolled end becomes paper thin.

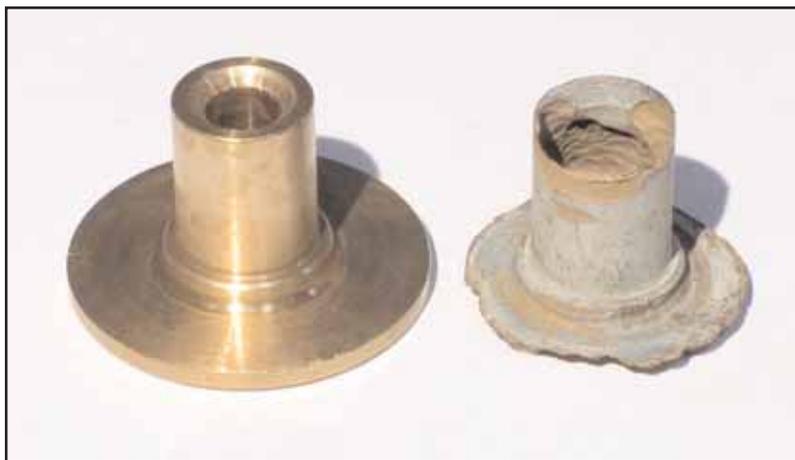
Good bypass

Damaged by  
low pH

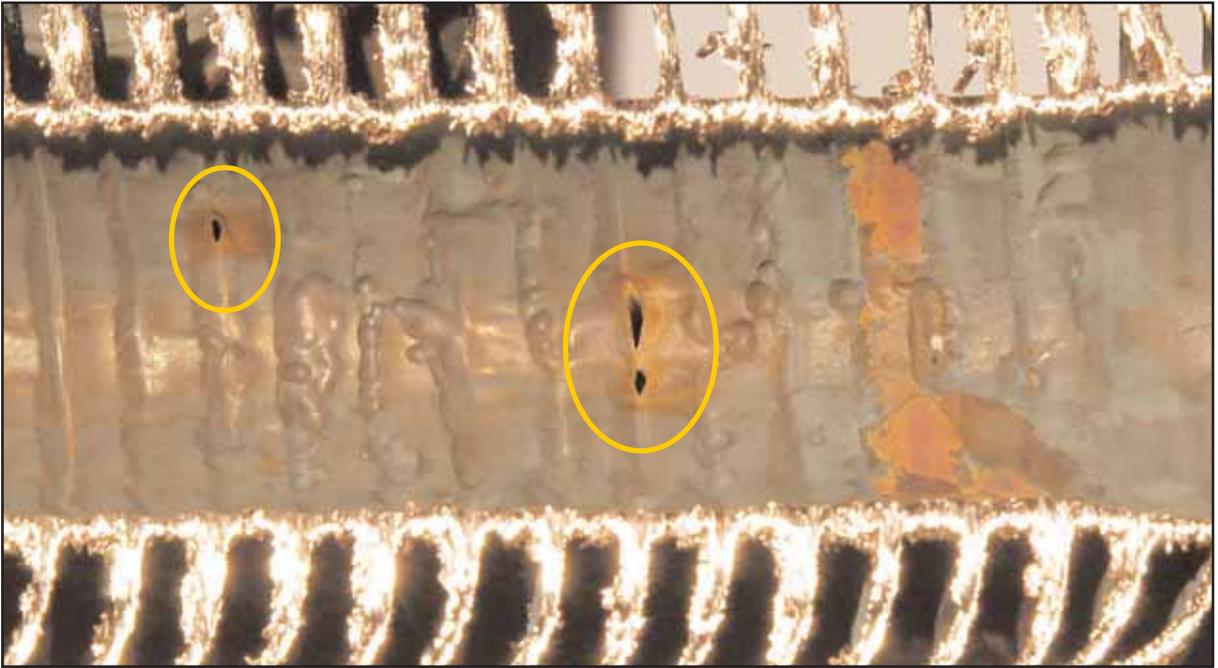
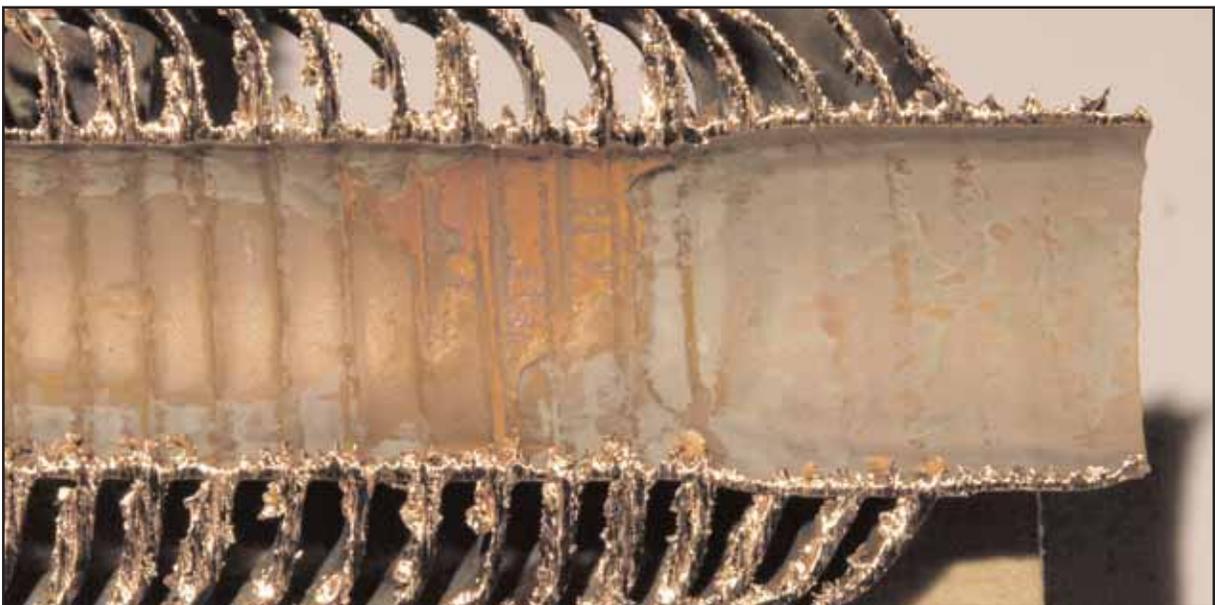
Pin holes develop from chemical corrosion.

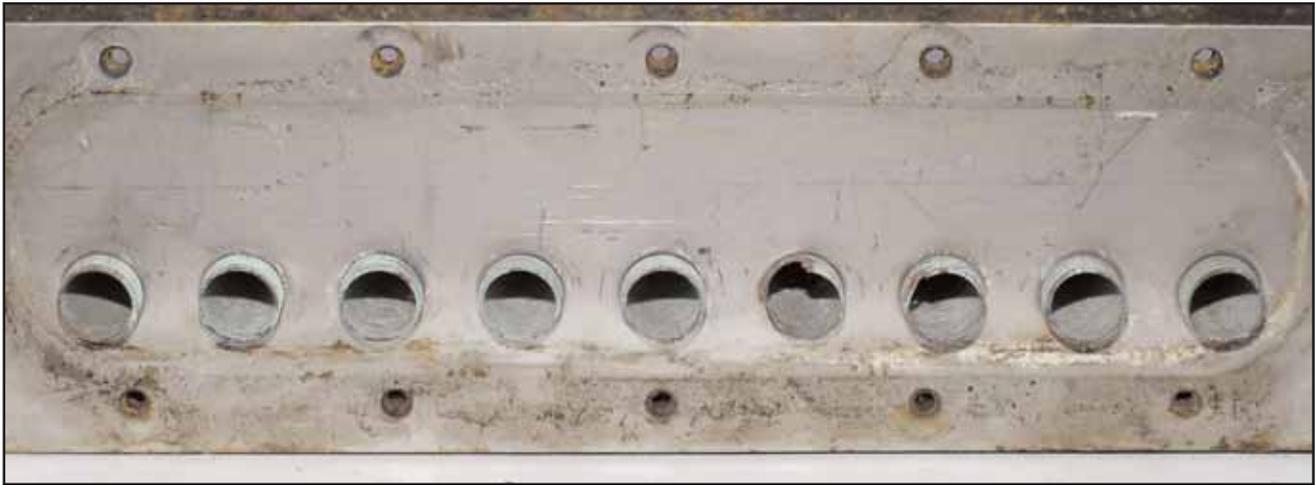
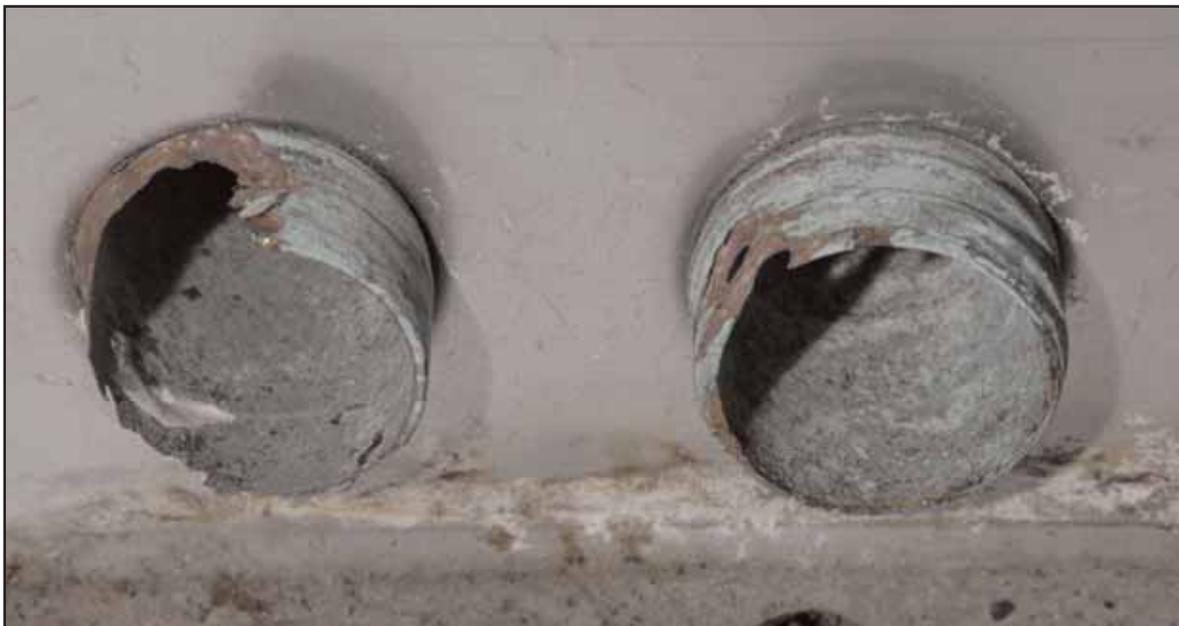
Automatic chlorinator installed close to the outlet of the heater, with no check valve installed between the chlorinator and the heater. Damage occurs to the heat exchanger when the system is shut off and the high concentration of chlorine is back-fed into the heater. The highly concentrated chlorine solution sits in the heat exchanger overnight and destroys the tubes along with all the other internal components.

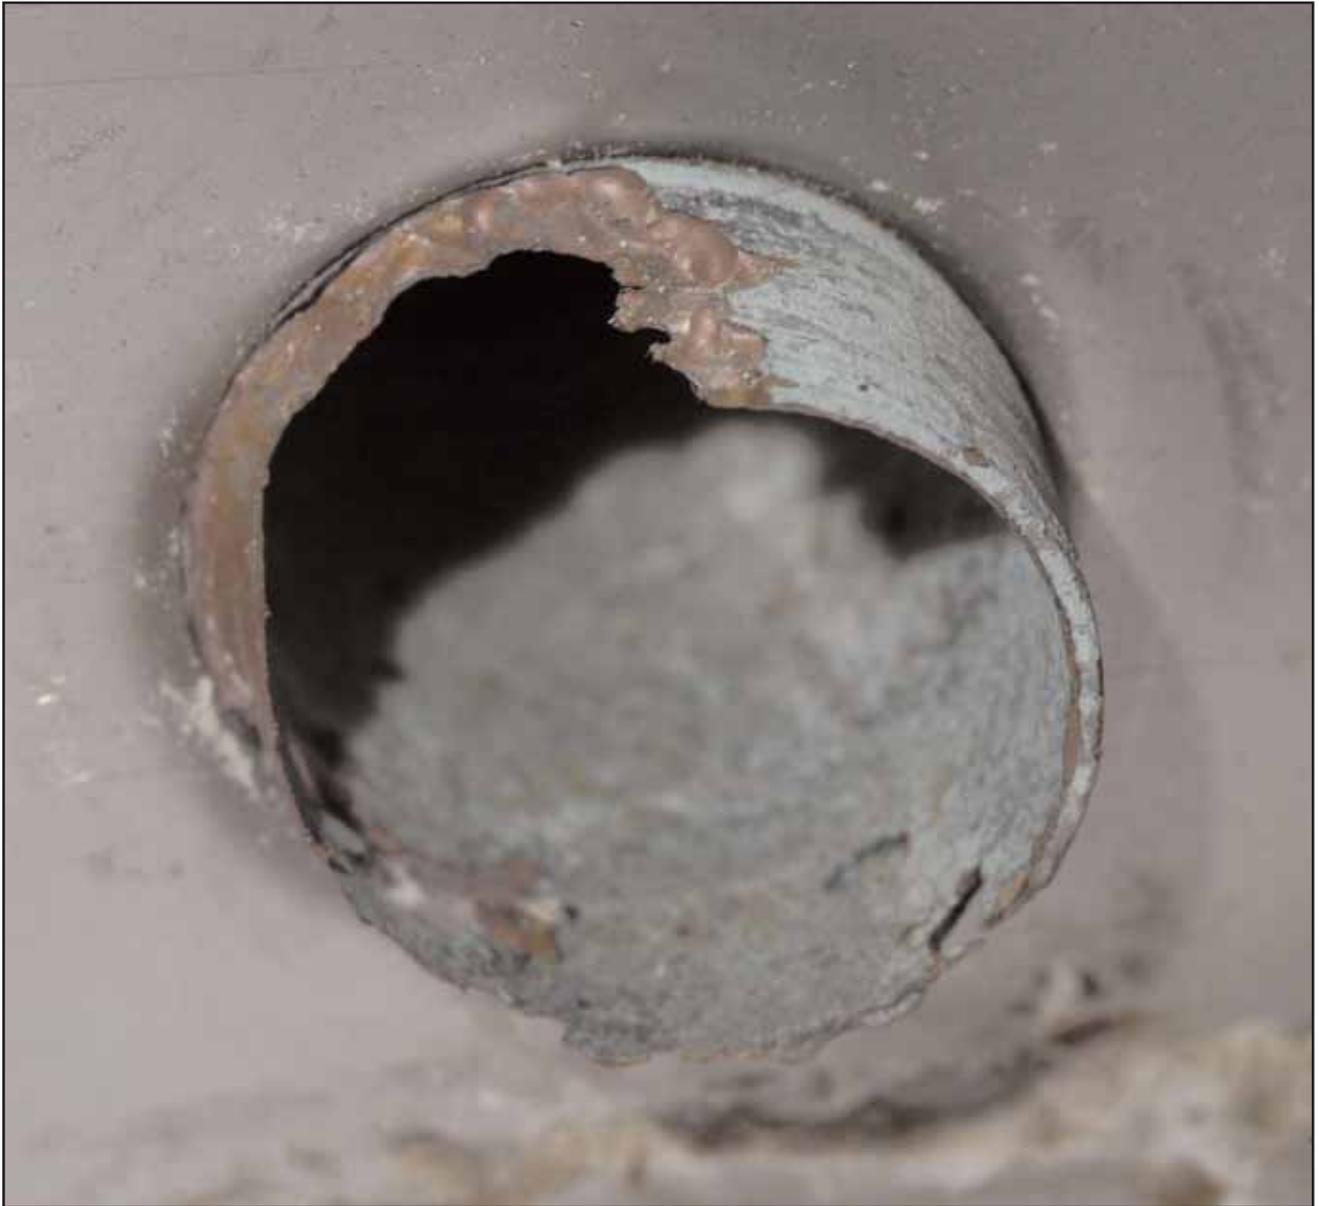
Tube gets eaten away by corrosive water.

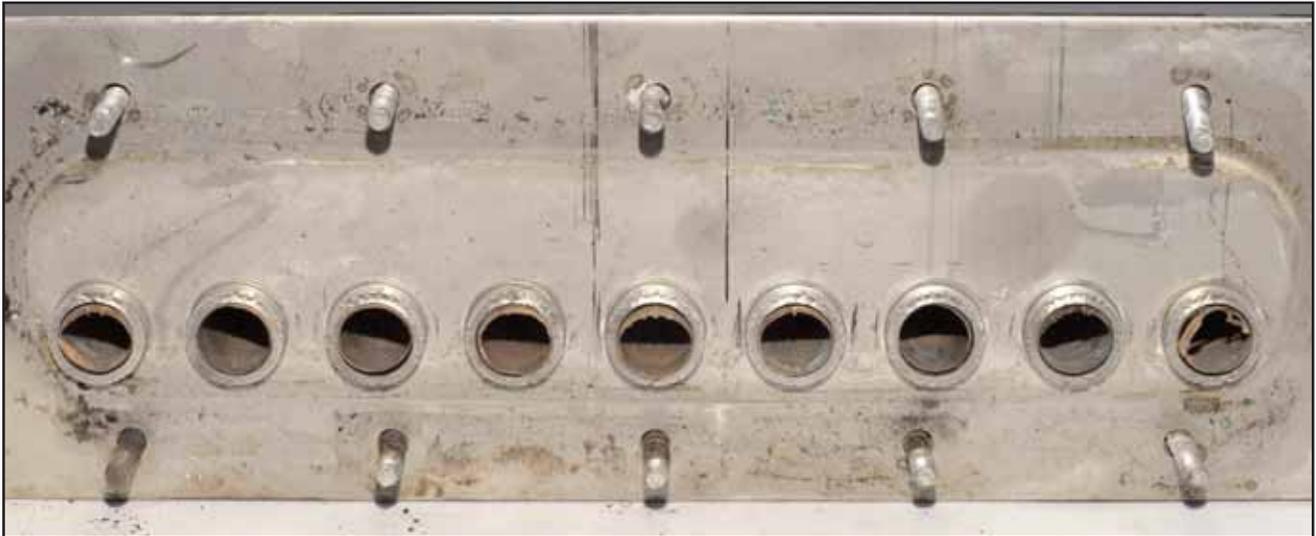
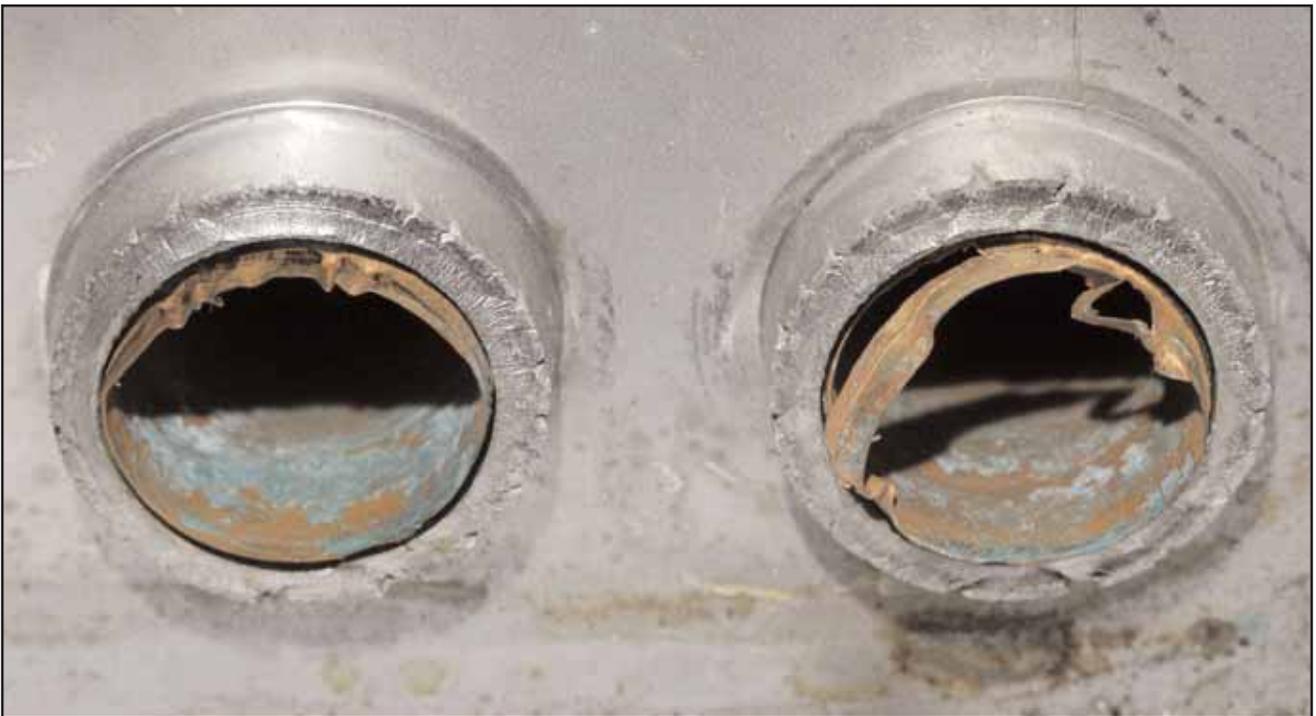
Damage caused by low pH

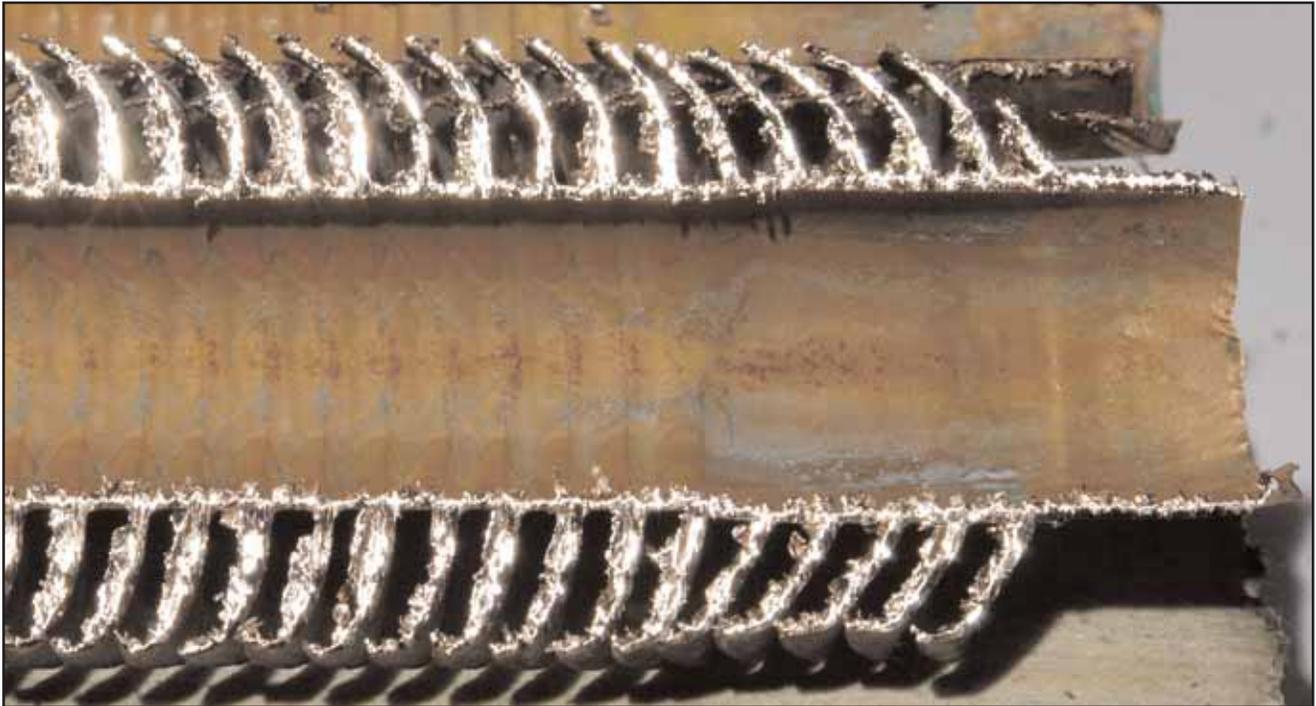
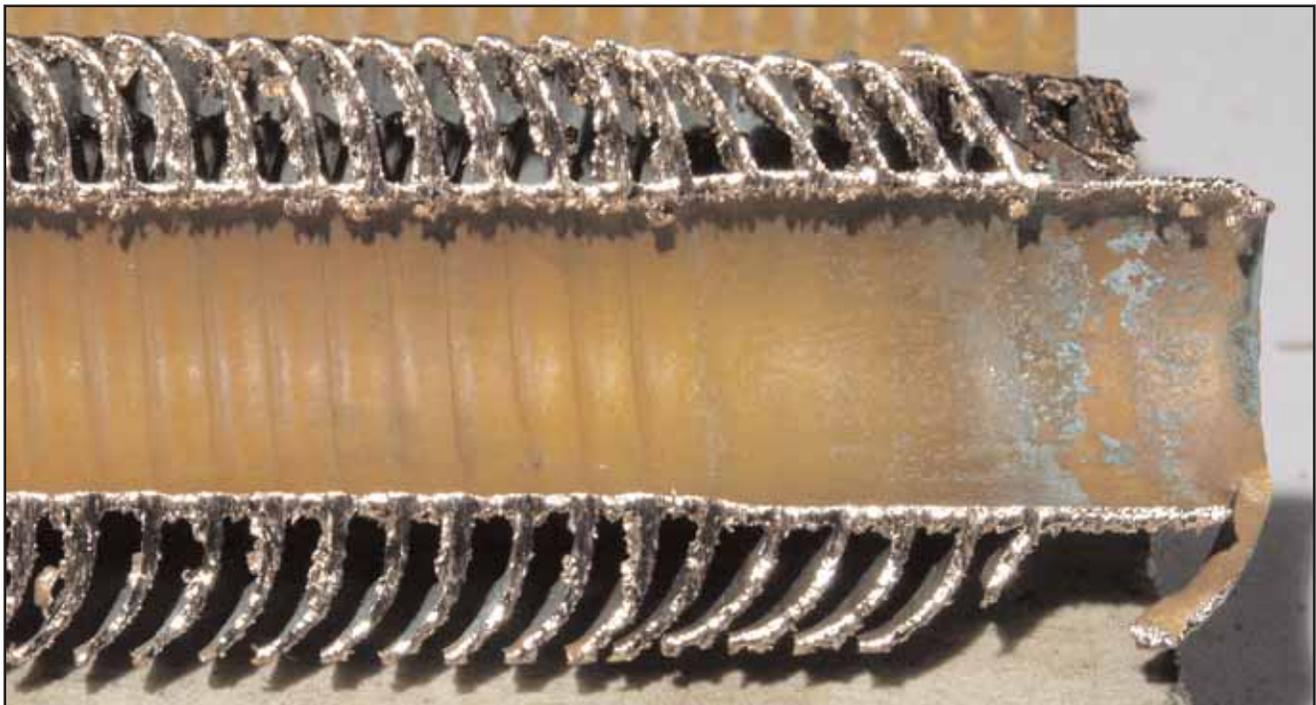
Damage caused by low pH

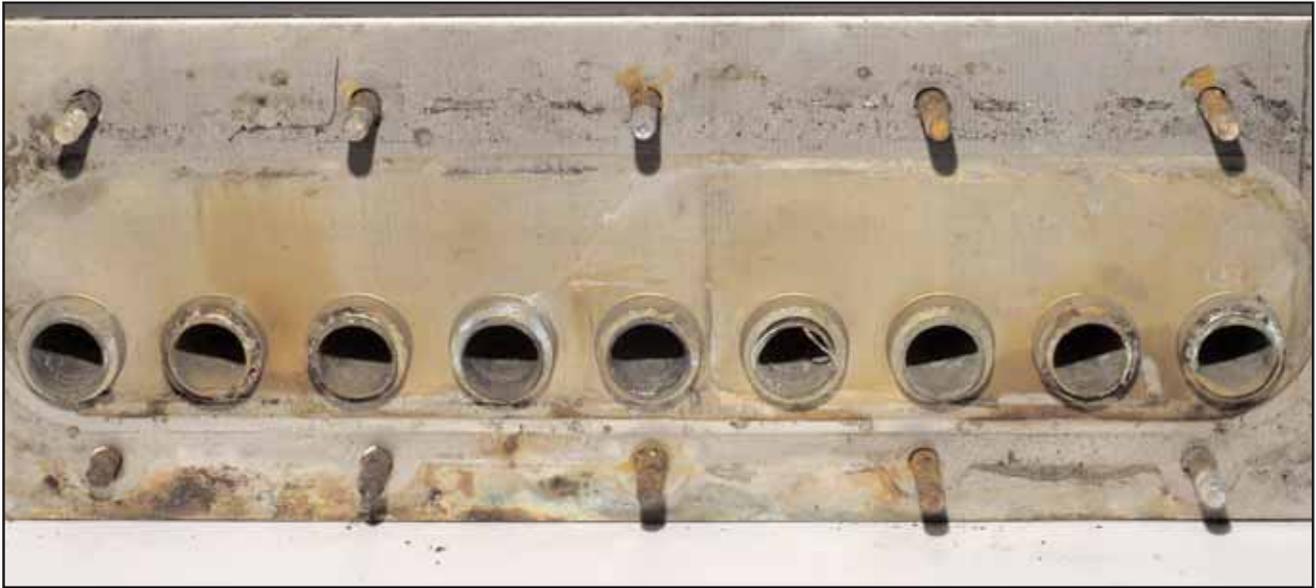
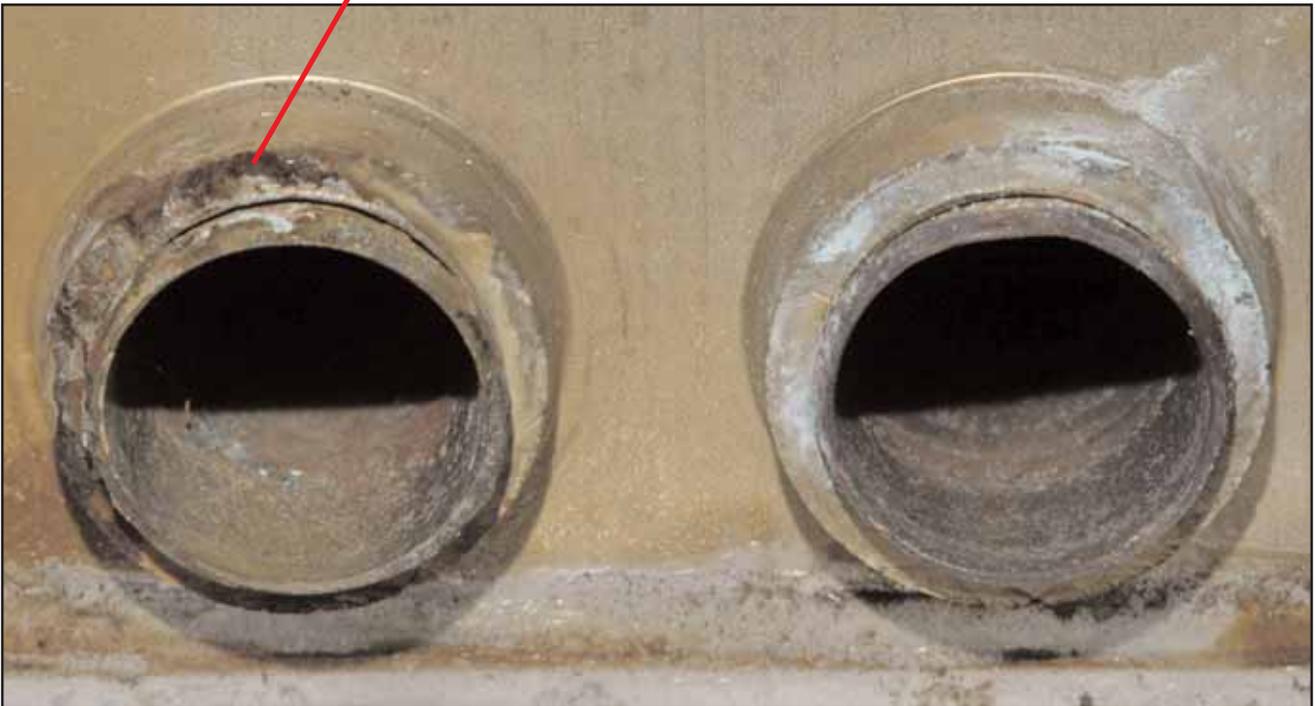
The salt attacked the stainless steel as well as the copper tube.

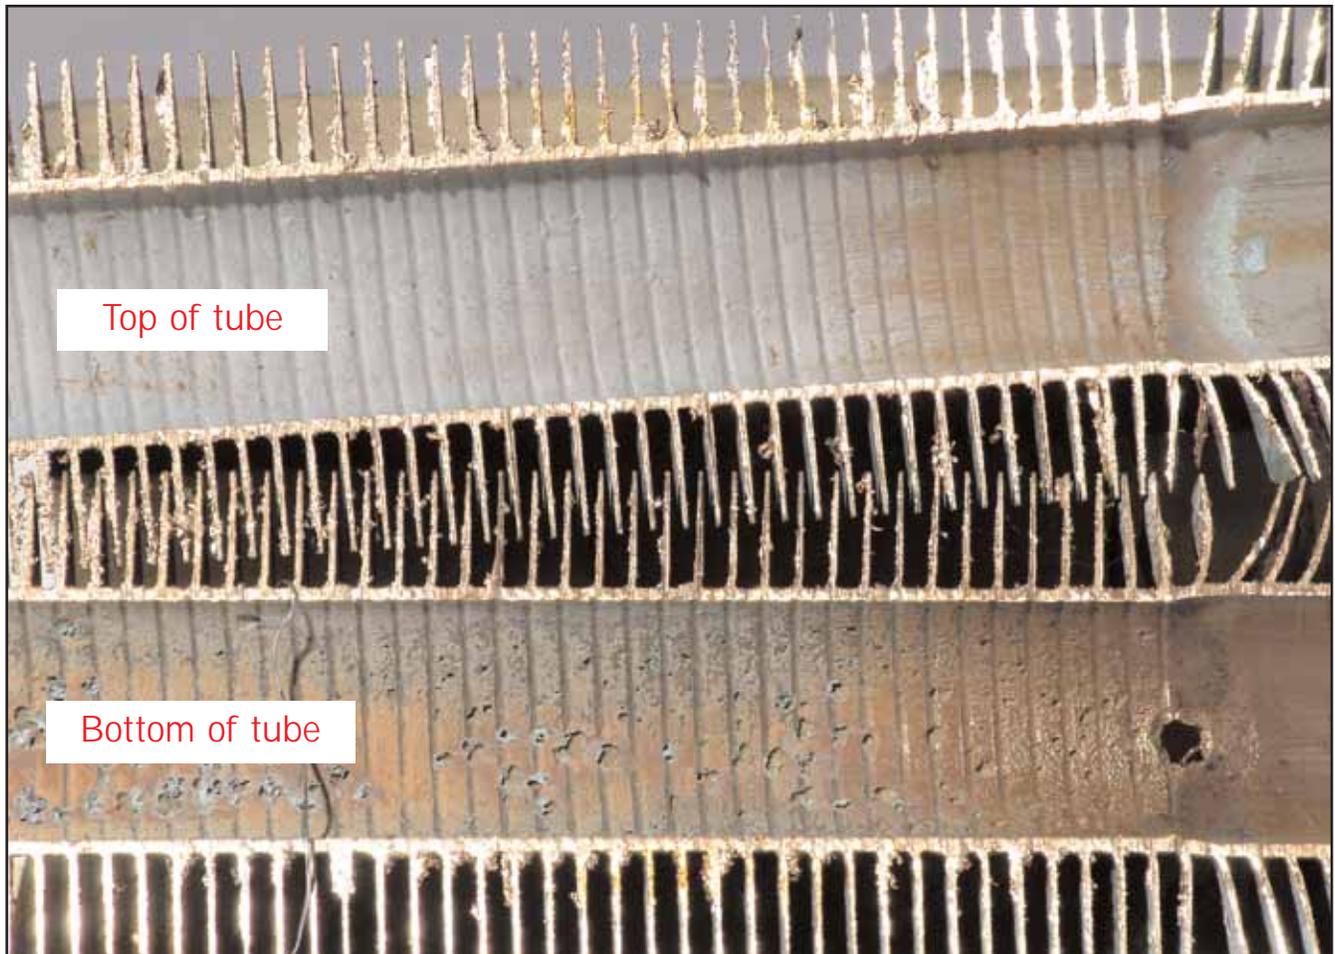
Pitting on the bottom of the tube and not on the top suggests that when the system is shut off, the deposits in the water settle. When at rest, they react with the copper leaving little craters in the surface of the tube.

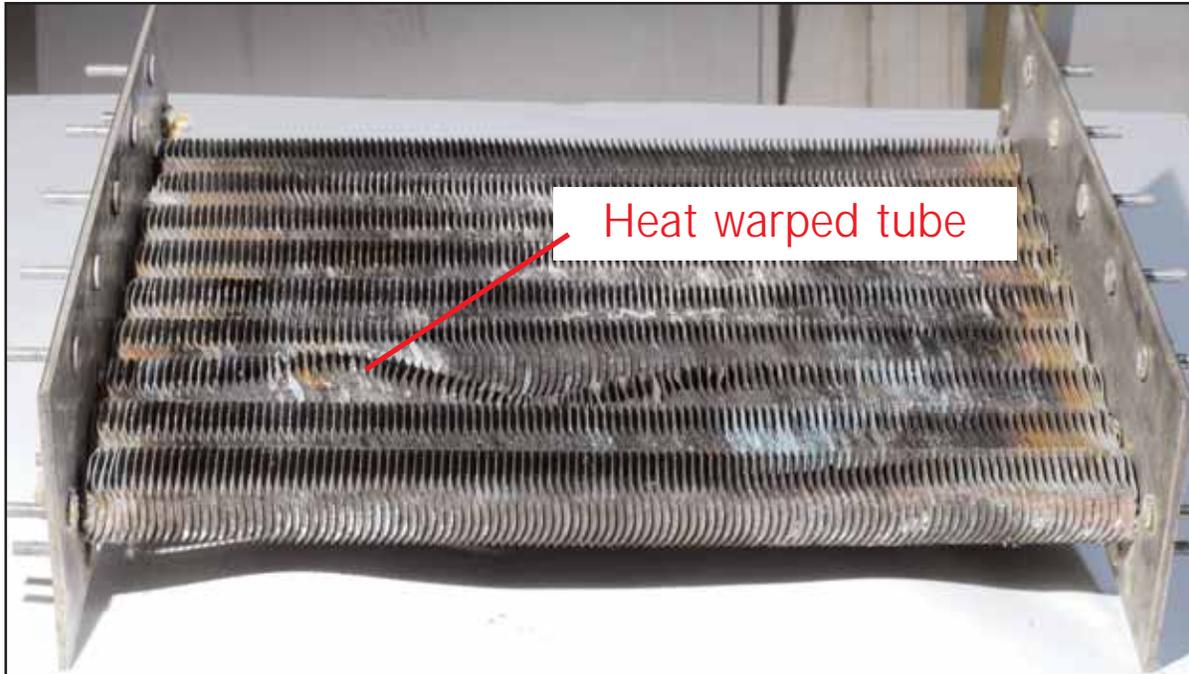
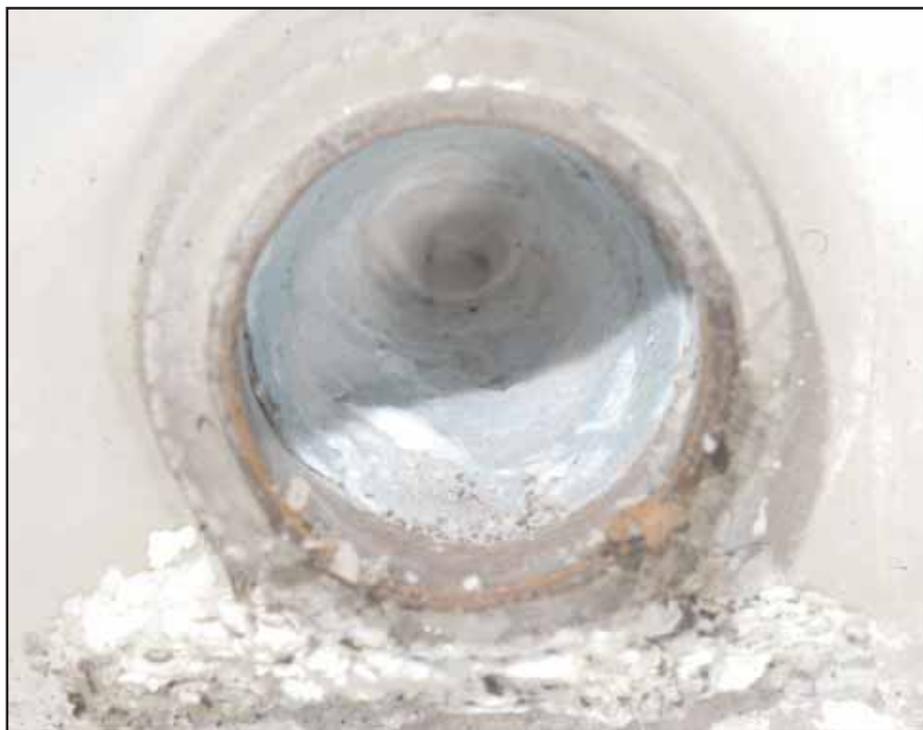
Completely plugged tube.

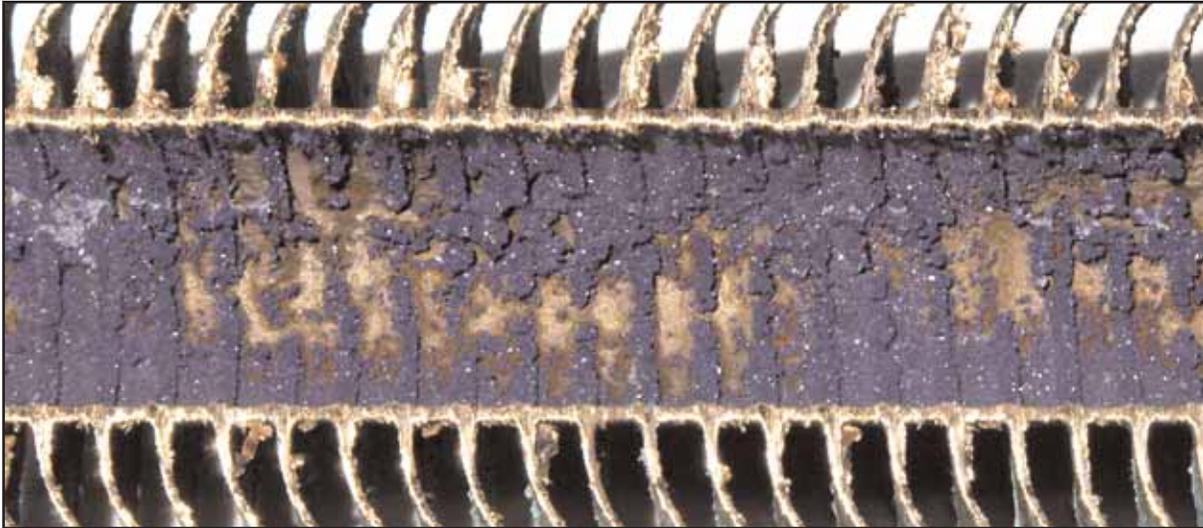
Purple crystal formation.

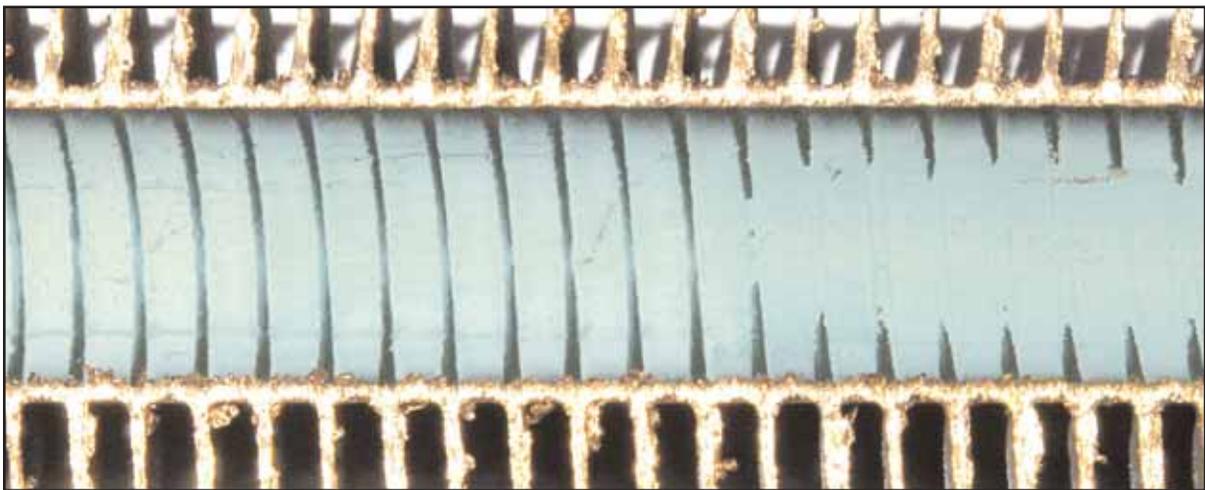
Light green-high chlorine levels

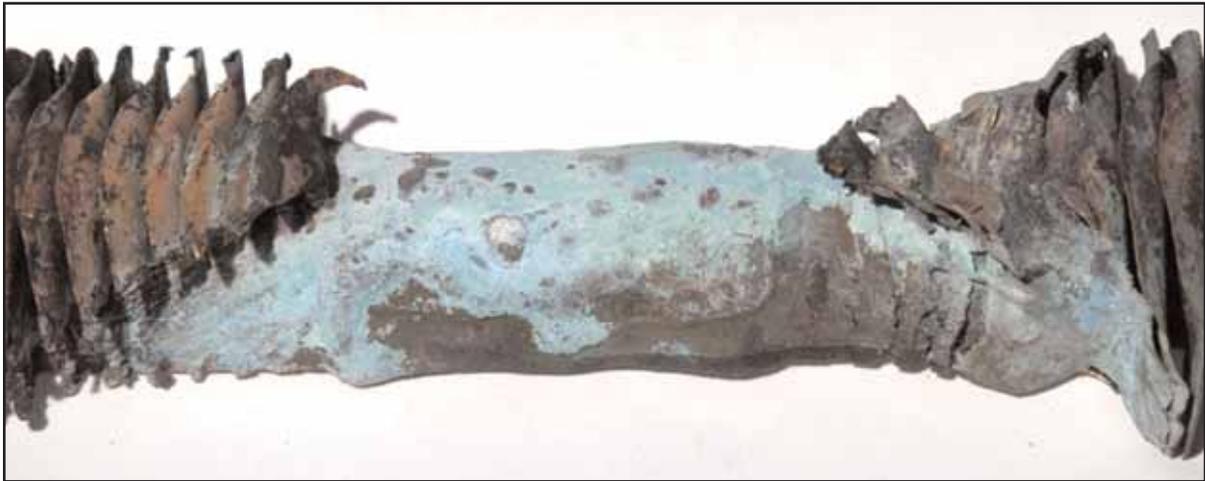
Pin hole leak. Leaking pool water can turn to Hydro-Chloric acid in the combustion chamber, causing the fins to get eaten away over time.

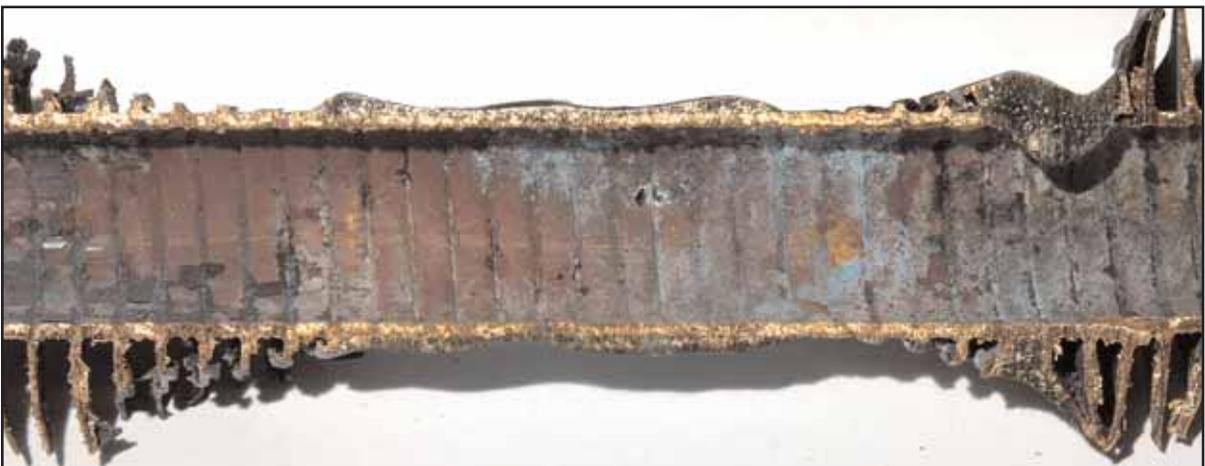
High chlorine levels caused a pin hole leak.
